## Blackjack 24 RTR Radio Tray Addendum

November 18, 2014

**Products:** PRB Blackjack 24™ (PRB08007)

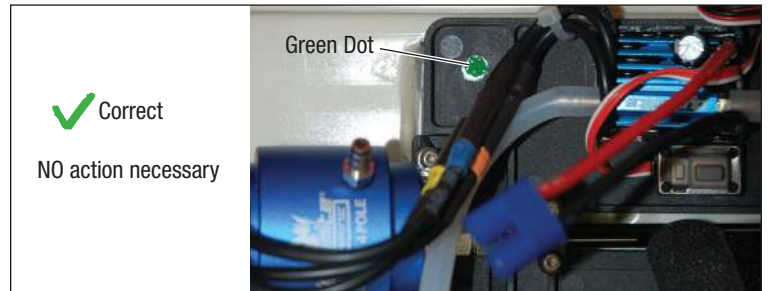
**Issue:** Some boats may have loose radio trays.

**What to Do:** Inspected radio trays are marked with a green dot as shown in this photo and are correct. If there is no inspection mark, check to make sure the radio tray is firmly attached to the hull.  
Contact Horizon Hobby Product Support if you have any questions.

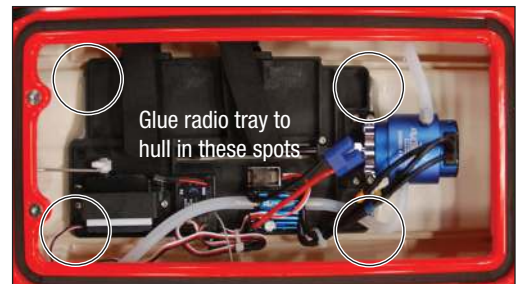
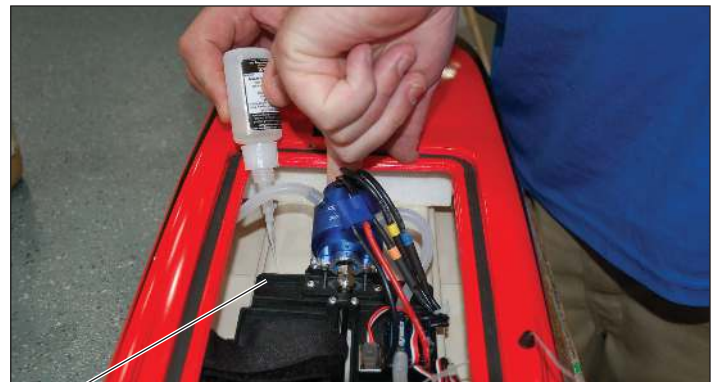
1. Pulling on the battery straps may loosen the radio tray from the hull.
2. If the radio tray becomes loose, apply CA (cyanoacrylate adhesive) between the tray and the hull as shown in these photos.

Carefully lift the radio tray up and apply CA between the tray and Hull

**IMPORTANT:** The motor is connected to the shaft, holding the tray in the hull. Carefully lift the tray while applying adhesive.
